# Manhole Inspection Summary

Manhole # S13EE\_032MH

Insp Date: **9/18/07 4:41 PM**

**Location** Address: **BELMONT RD**

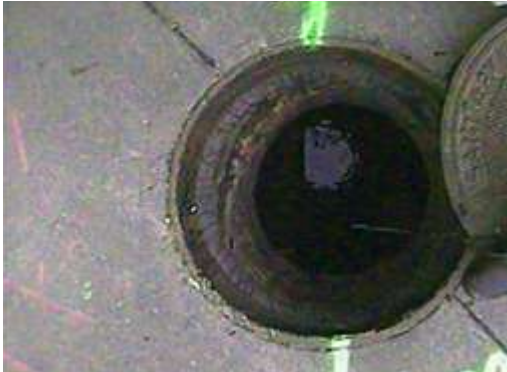
Top View

Offset: **2** (in.)

FRAME OFFSET

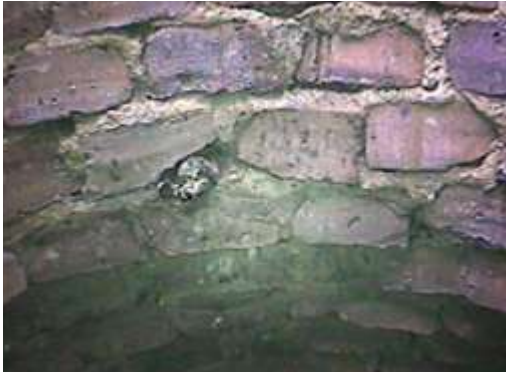
Defect 1

Count: **3** Missing: **3** ☒ **Corroded**

MISSING/CORRODED RUNGS

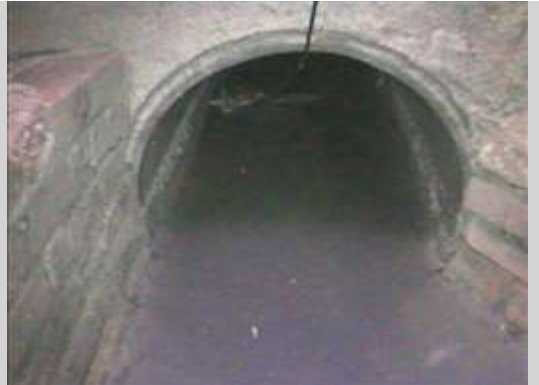
12 O'Clock Outflow

18 in. Circular Gravity Sewer  
Pipe Out @ 12 O'Clock

Pipe Height: (in.) Direct  
Pipe Material: **Clay** ☐ Pipe Lined  
Invert Depth: **8.16** (ft.) Flow Characteristics: **Slow**  
Deposits: ☒ None ☐ Mud ☐ Sludge ☐ Debris ☐ Grease  
Silt Depth: (in.) Deposits Extent:  
Infiltration: **None** Pipe Seal Cond: **Sound**

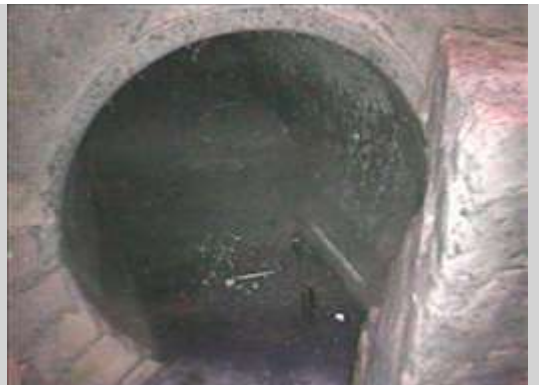
3 O'Clock Inflow

18 in. Circular Gravity Sewer  
Pipe In @ 3 O'Clock

Pipe Height: **19.2** (in.) Rod and Bar (Angled)  
Pipe Material: **Clay** ☐ Pipe Lined  
Invert Depth: **8.06** (ft.) Flow Characteristics: **Slow**  
Deposits: ☒ None ☐ Mud ☐ Sludge ☐ Debris ☐ Grease  
Silt Depth: (in.) Deposits Extent:  
Infiltration: **None** Pipe Seal Cond: **Sound**

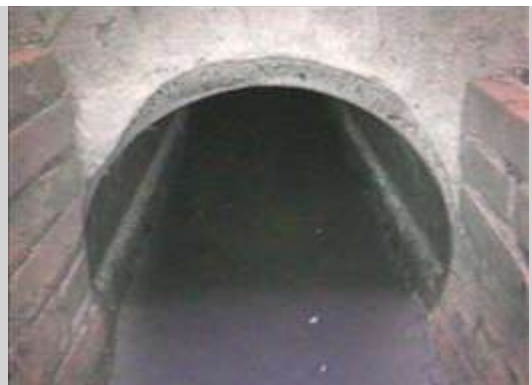
6 O'Clock Inflow

18 in. Circular Gravity Sewer  
Pipe In @ 6 O'Clock

Invert Depth: **8.22** (ft.) Flow Characteristics: **Slow**

Infiltration: **None** Pipe Seal Cond: **Sound**
